MUD RUN DAM

NDI NO. PA-00690

PHASE I INSPECTION REPORT NATIONAL DAM INSPECTION PROGRAM

Name of Dam: MUD RUN DAM, NDS NO. PA-00690
State & State No. PENNSYLVANIA, 54-27
County: SCHUYLKILL
Stream: MUD RUN
Date of Inspection: NOVEMBER 1, 1978

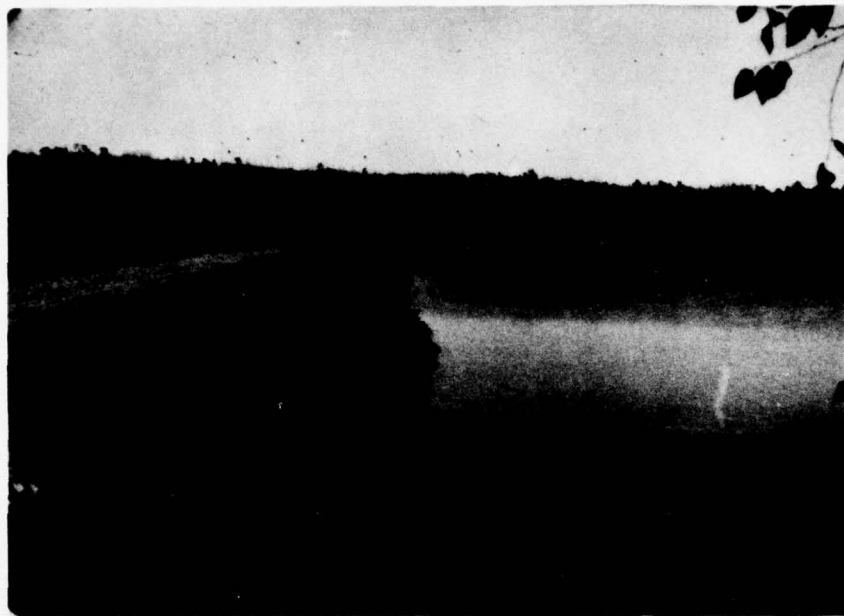
Inspection of the downstream slope surface did not reveal any symptoms of distress. The slope surface is composed of cobbles and is weed covered for the most part. There was no evidence of slope seepage observed. The upstream slope surface is also composed of cobbles and stone with some light weed growth near the top of the slope. The downstream slope was measured at 2.3H to 1V. The upstream slope is too short to measure an average slope angle; however, the available plans indicate a slope ratio of 2H to 1V (Appendix A, Plate A-I).

Upstream
Embankment Slope

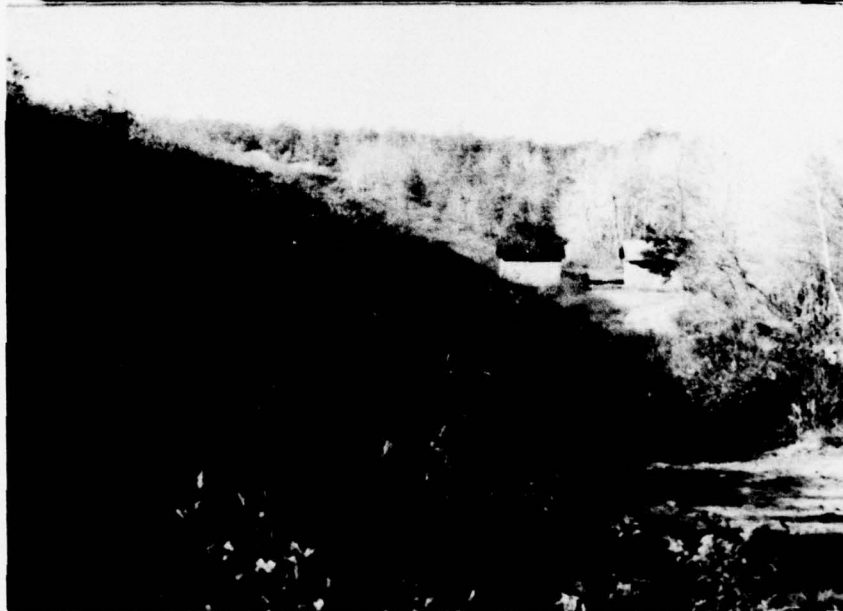
Seepage water was observed along most of the length of the downstream toe. Flow of seepage water was barely detectible. A valve on the blowoff line is not properly closed and permits water to leak from the reservoir.

Downstream
Embankment Slope

4. That the spillway outlet channel be cleared of all debris and obstructions.
5. That the seepage along the toe of the embankment be monitored on a regular schedule. Volume and clarity shall be recorded for comparison and analysis. Such records should include the elevation of the water level in the reservoir at the time of the observation. If significant increase in flow is noted or if the seepage discharge becomes turbid, immediate steps should be taken to correct the condition.

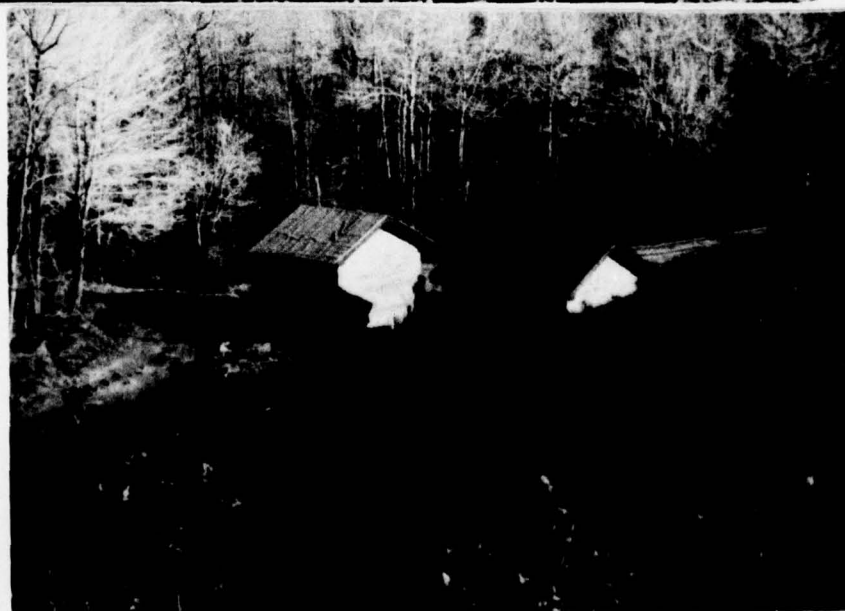
As indicated above, the valves which control the outflow from this dam are in poor condition. The stem yokes will probably need replacement as they are nearly rusted through. One of the valves is leaking, permitting considerable flow in the outlet ditch below the valve house. This condition should be corrected.

Valve Houses

1. That all control valves for this dam be put into good repair and made operable and that a regular program of maintenance and service be developed and put into action. The valves should be operated at least once each year.
